NATIONAL TRANSPORTATION SAFETY BOARD

Group Chairman's Factual Report

STRUCTURES

DCA13MA120

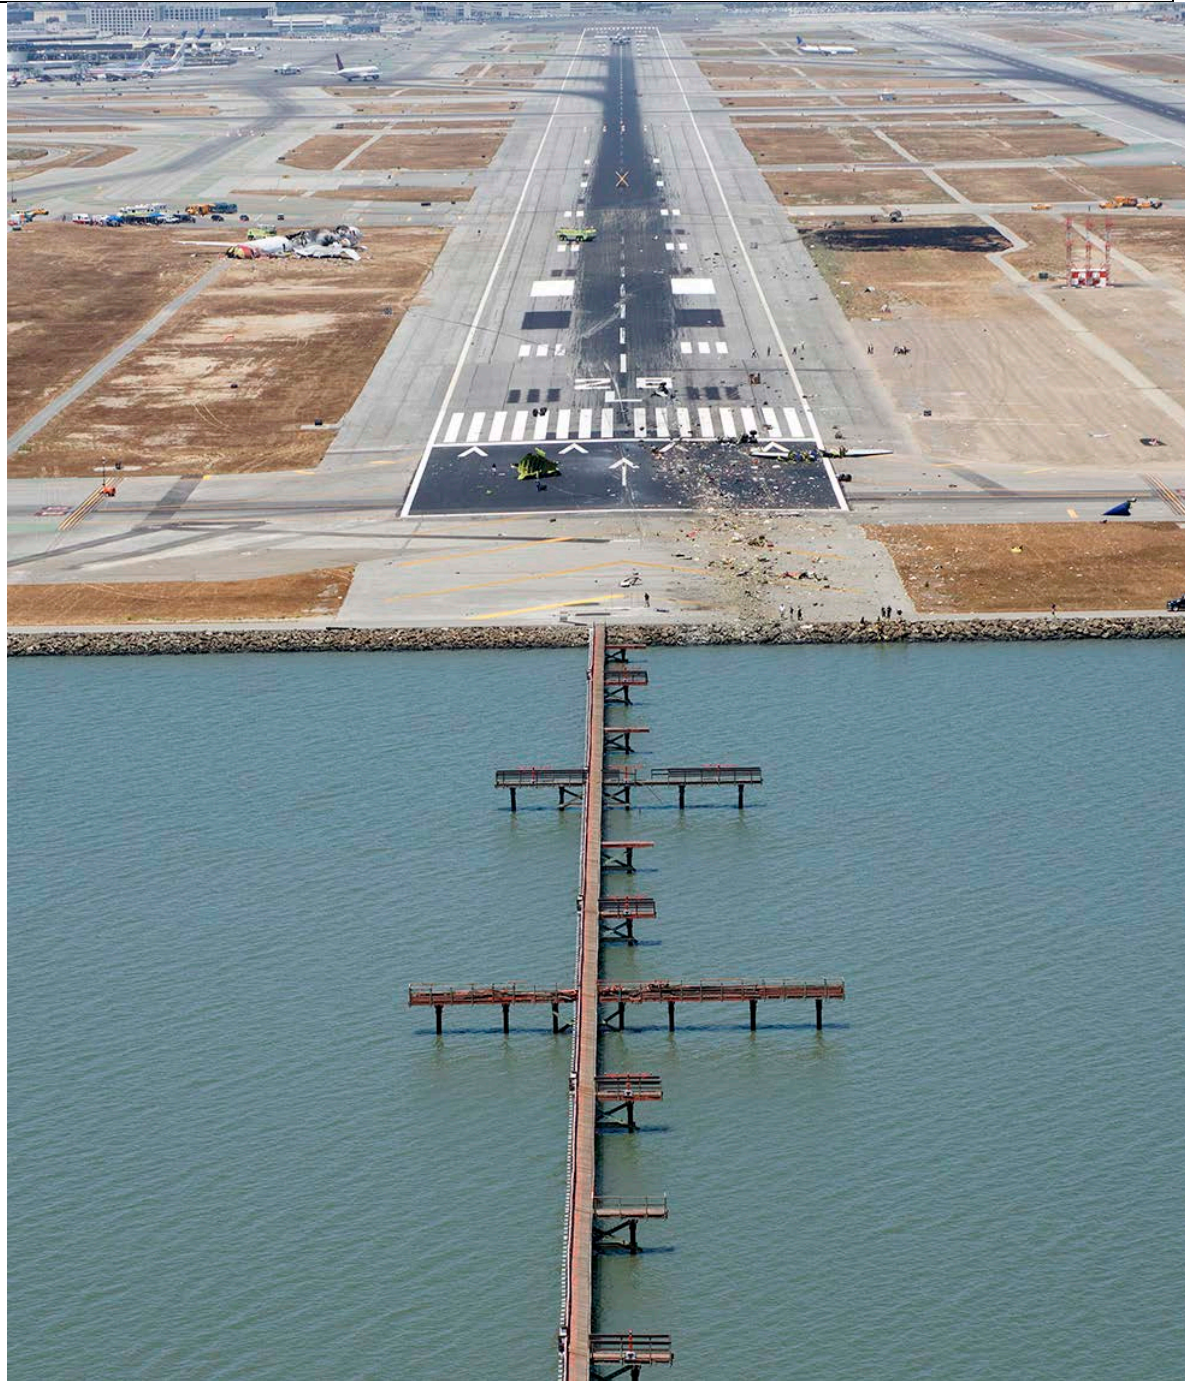
Description: HL7742 wreckage debris as viewed flying the approach to runway 28L.

Photo 1: HL7742 wreckage viewed east to west on runway 28L.

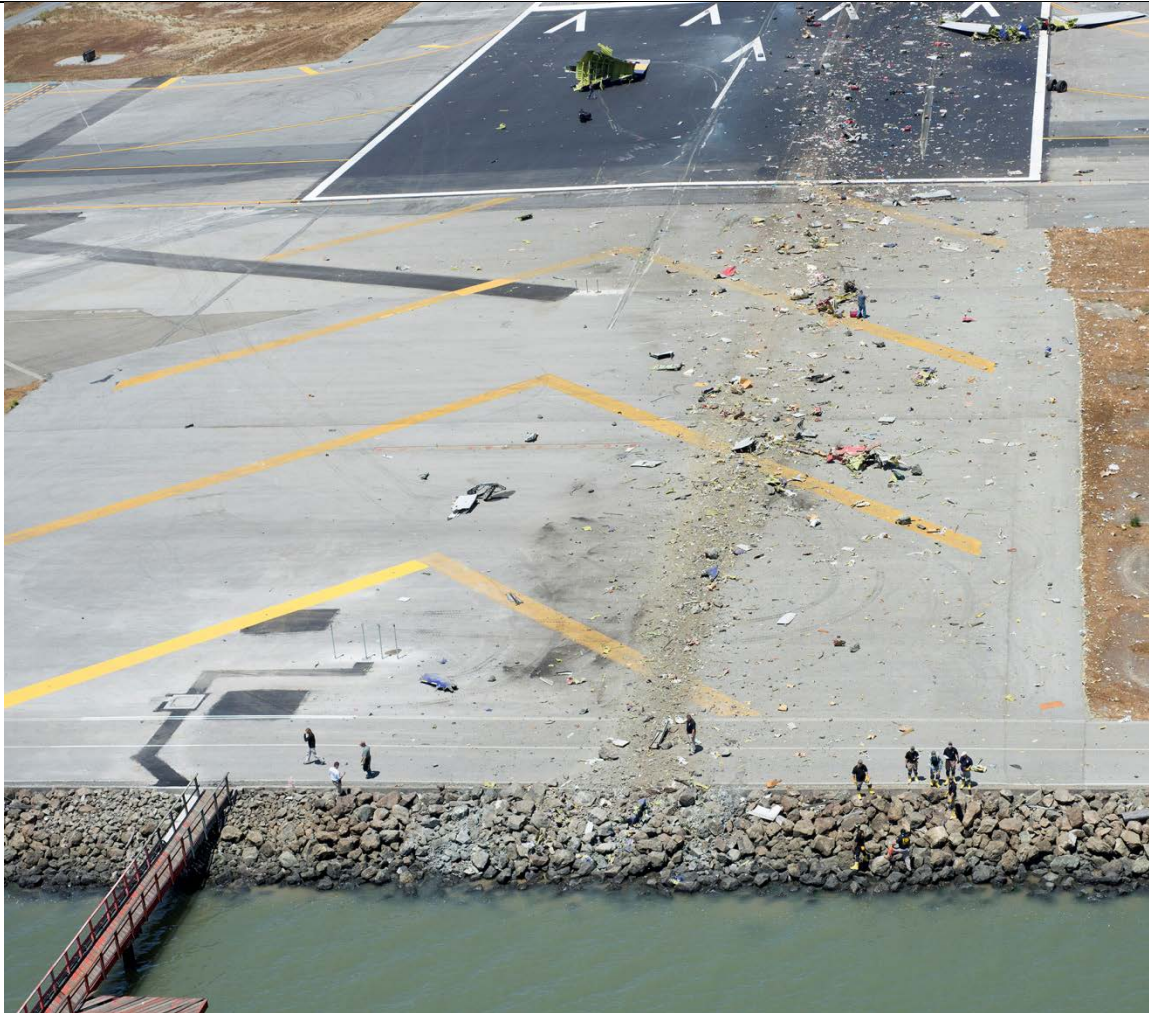
Description: HL7742 seawall impact marks.

Photo 2: HL7742 seawall impact marks.

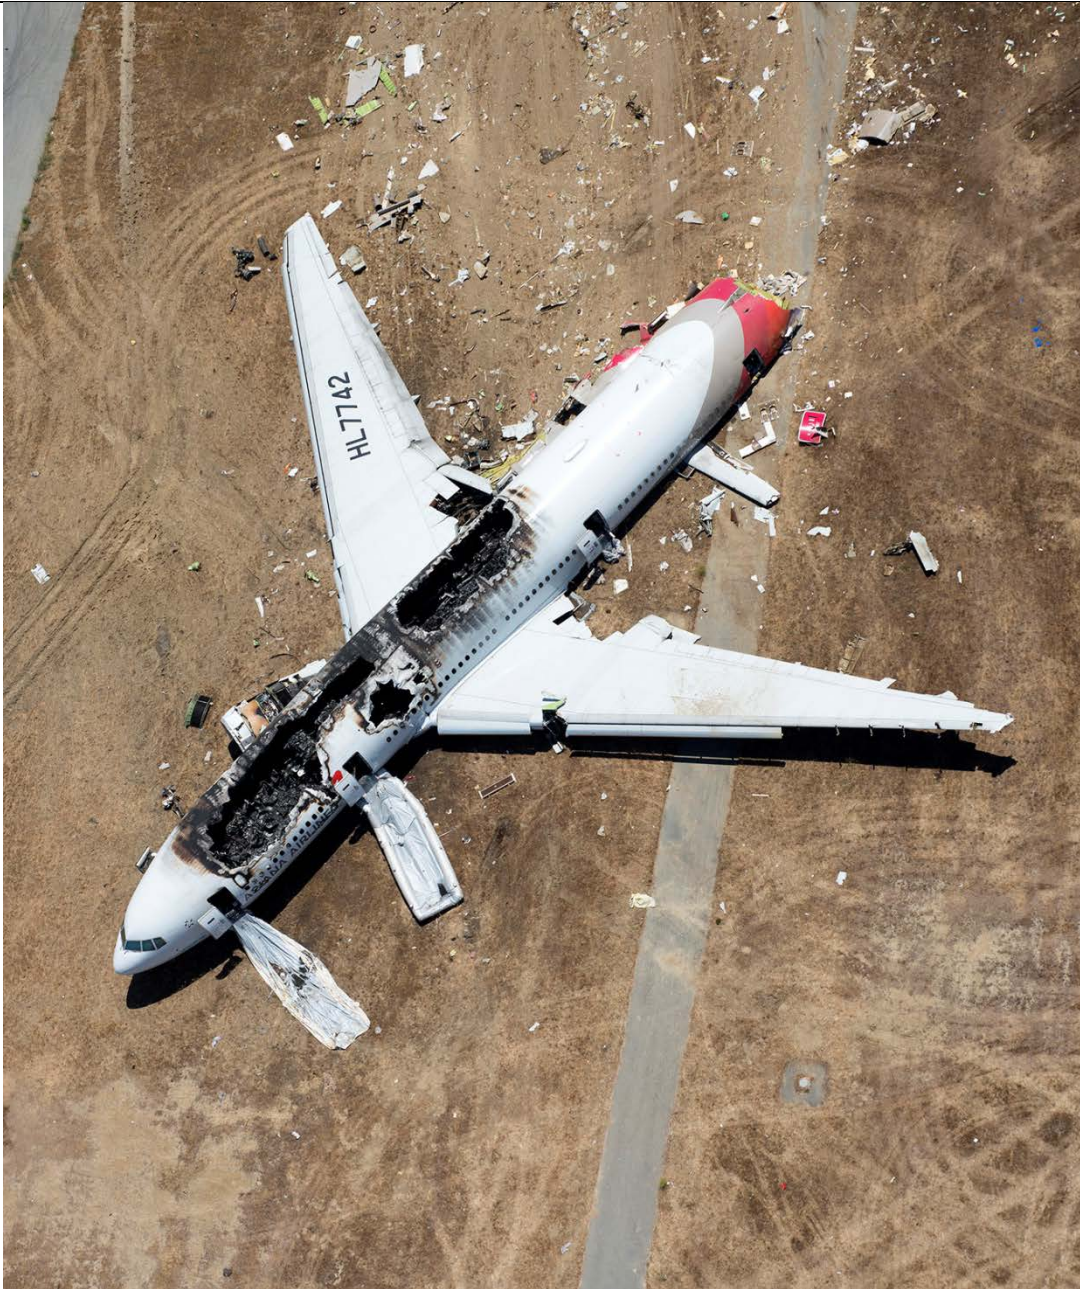
Description: HL7742 overhead view of fire damage.

Photo 3: HL7742 fuselage fire damage.

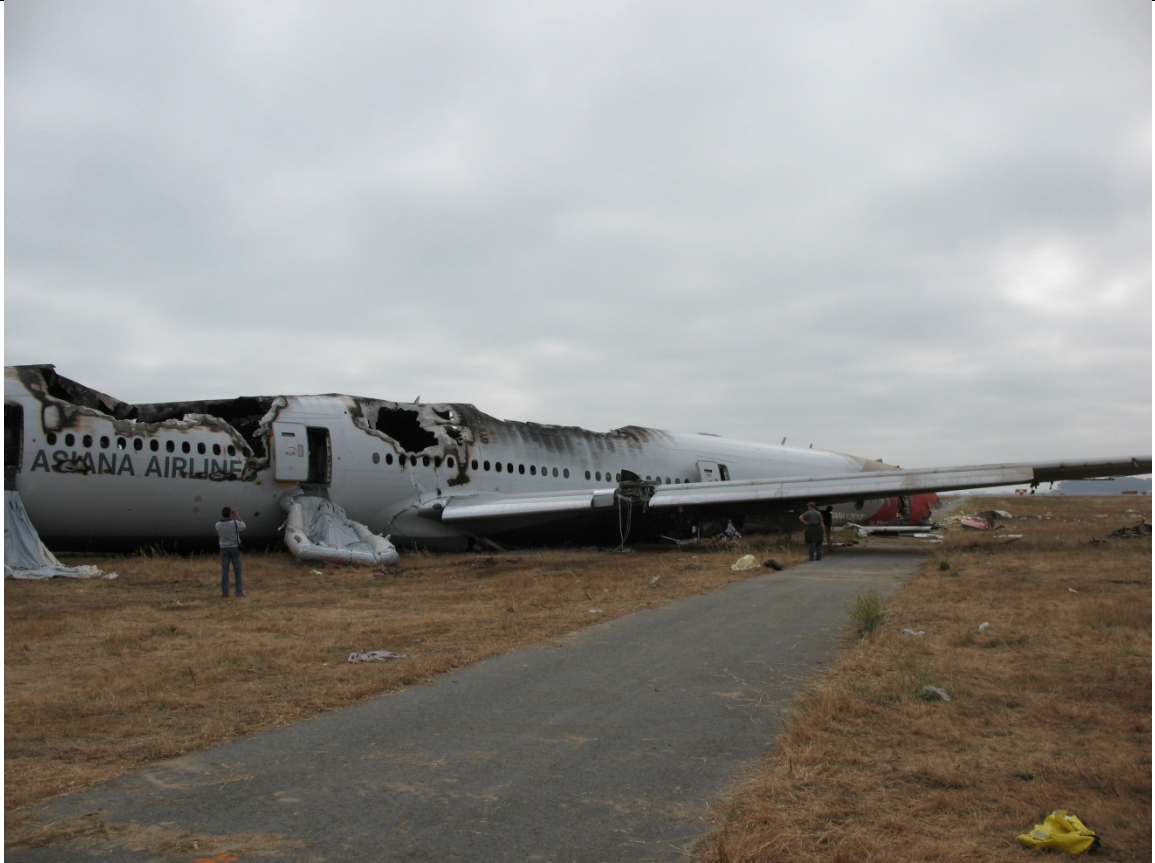
Photo 5: HL7742 fuselage viewed from the left hand side

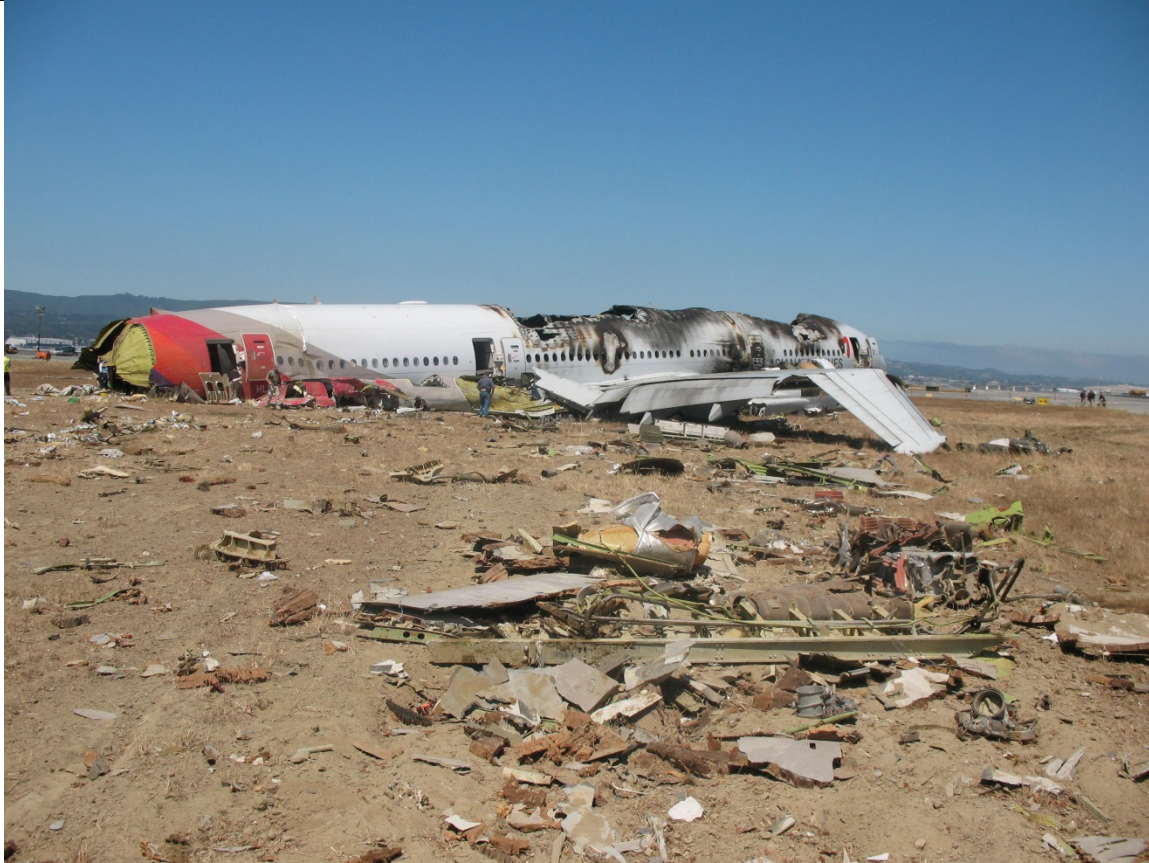
Description: HL7742 fuselage viewed from the right hand side.

Photo 6: HL7742 fuselage viewed looking from the right hand side.

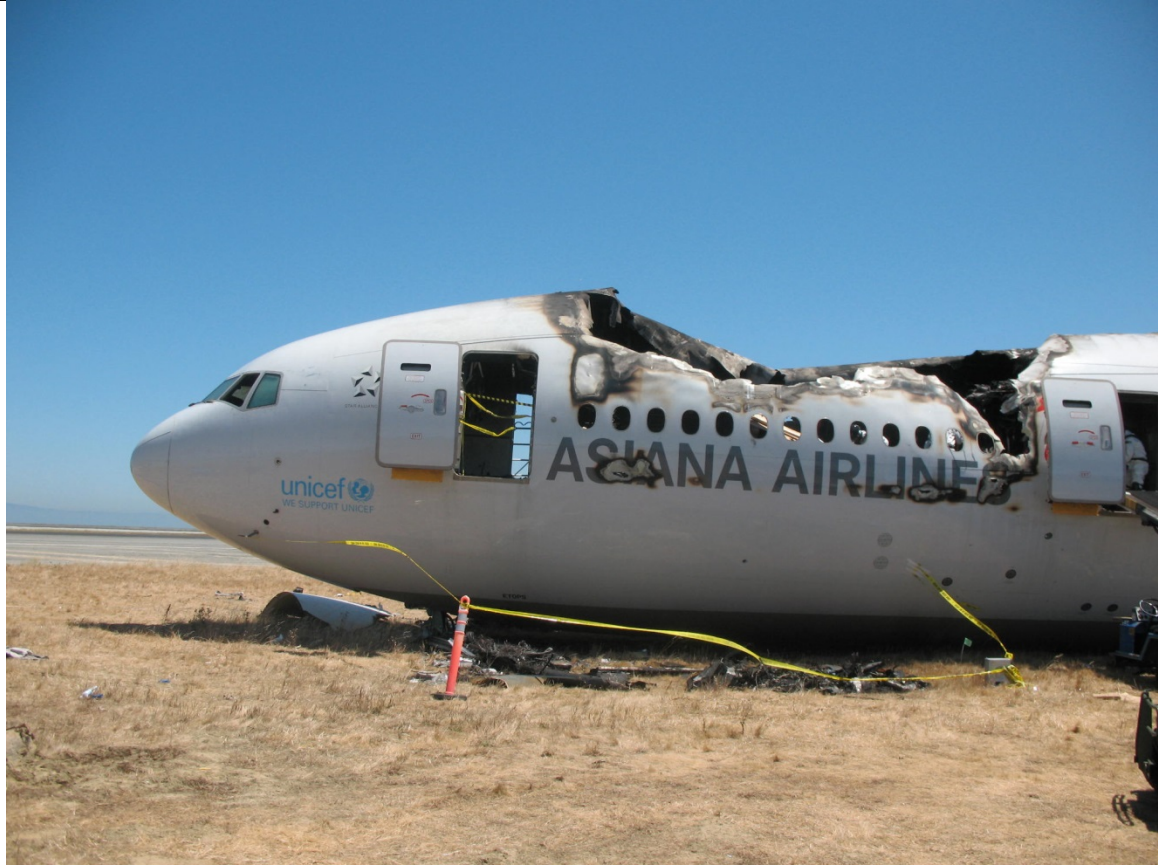
Description: Section 41, passenger entry doors (PED) 1 left (L) & PED 2L.

Photo 7: Section 41 and PED's 1L & 2L.

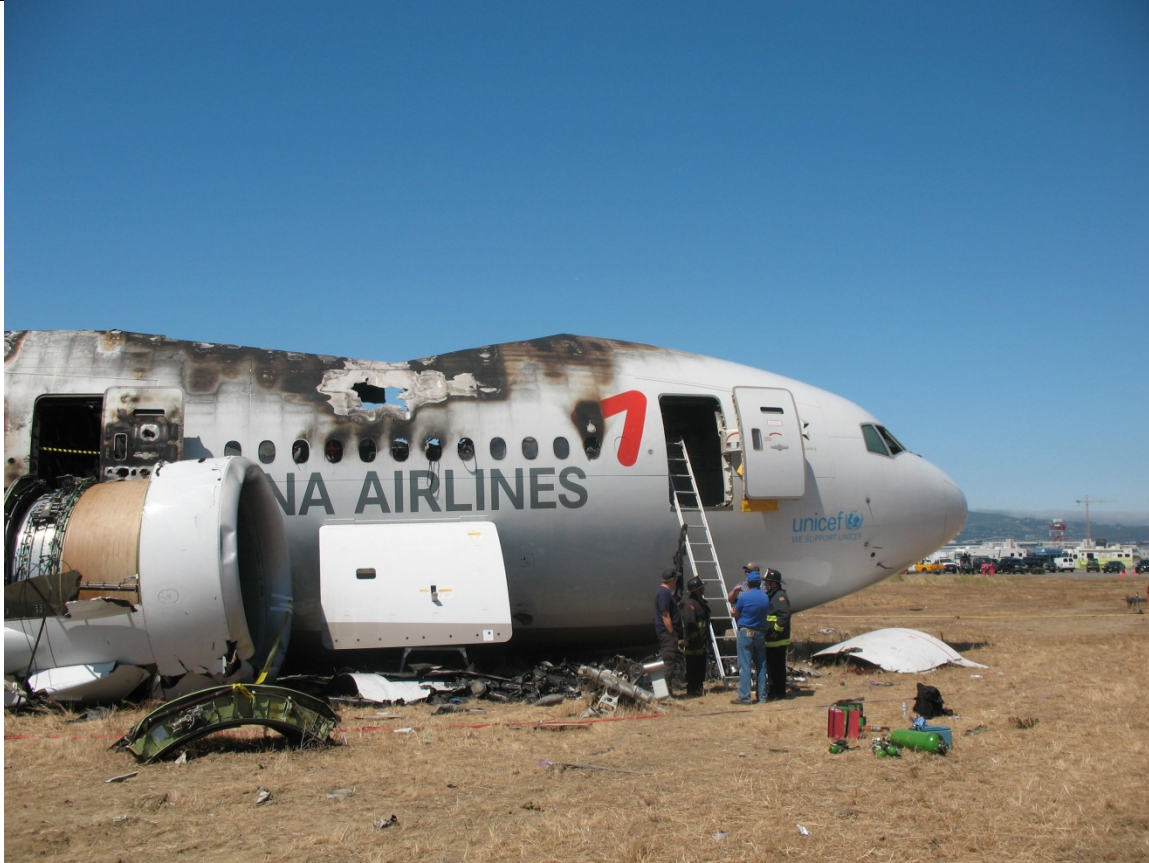
Description: Section 41, PED 1R, PED 2R, LFCD & engine #2.

Photo 8: Section 41, PED's 1R & 2RL, LFCD & engine #2.

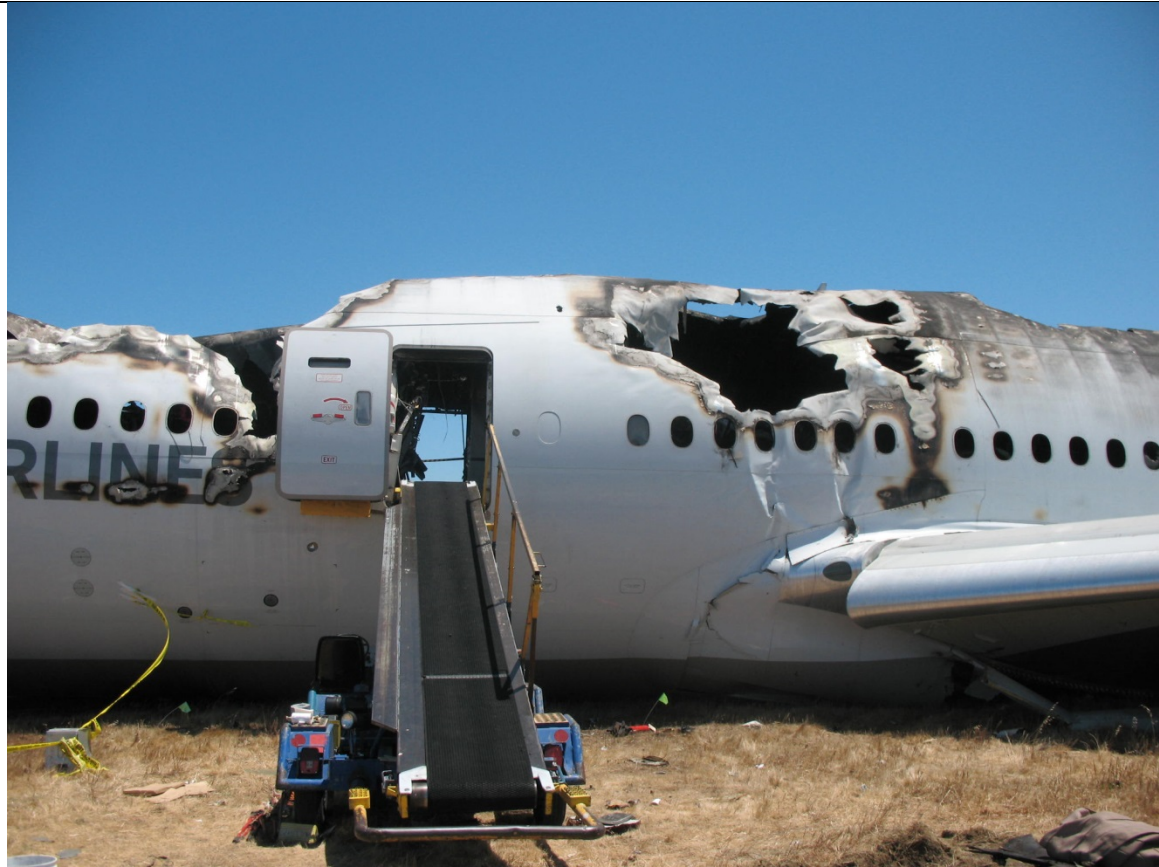
Description: Section 43 & PED 2L.

Photo 9: Section 43 & PED 2L.

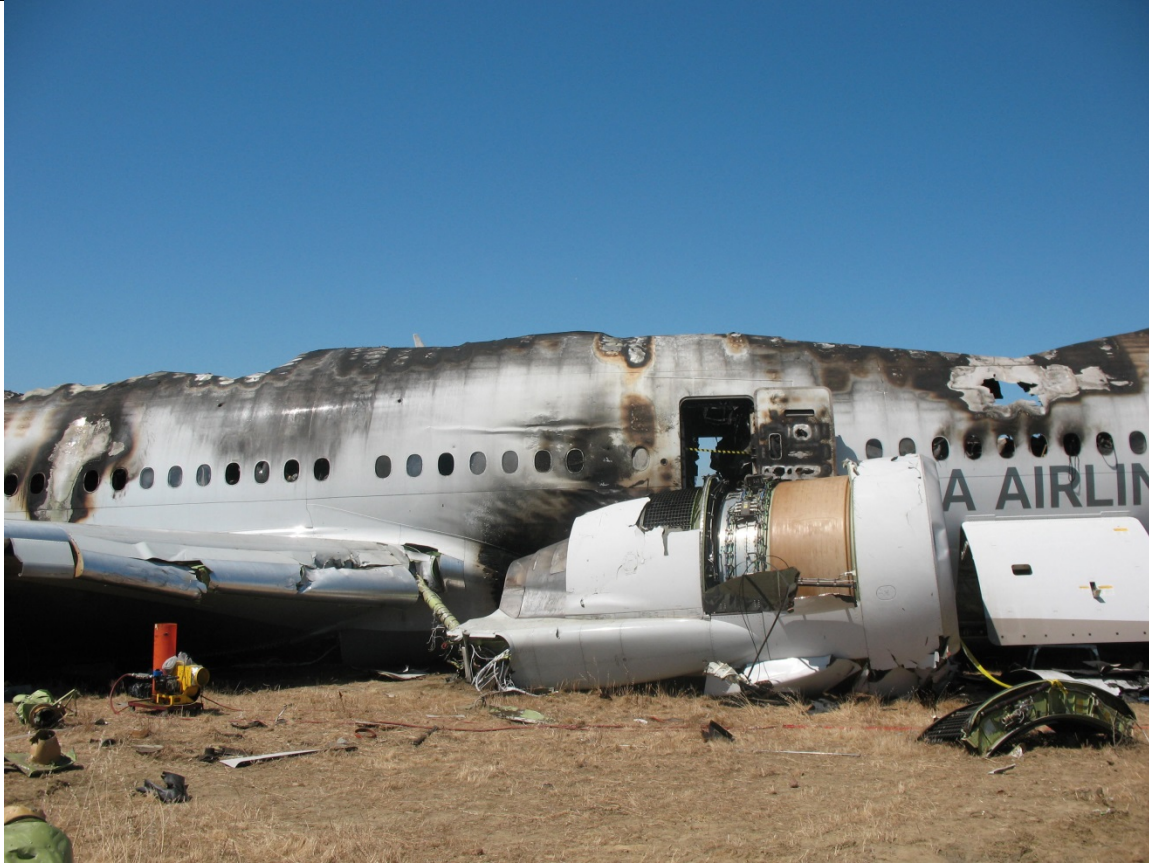
Description: Section 43 & PED 2R.

Photo 10: Section 43, engine #2 & PED 2R.

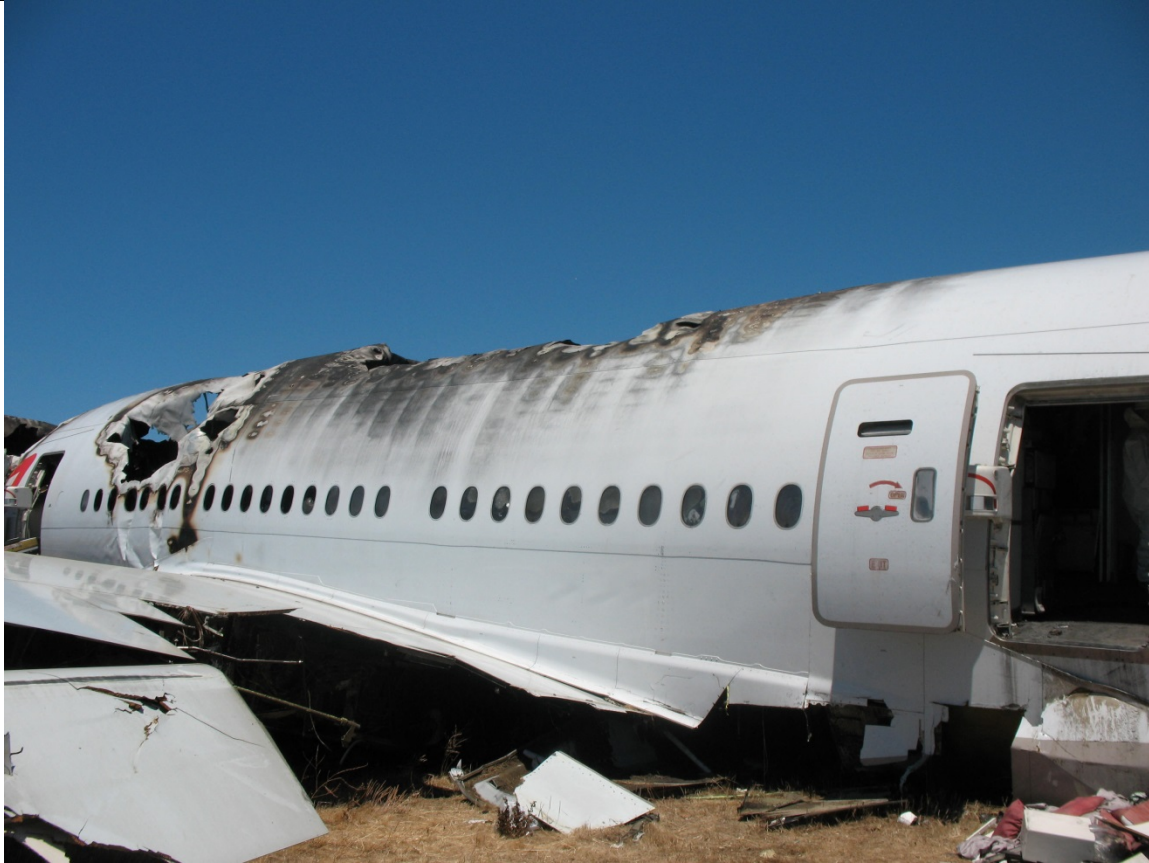
Description: Left side view of sections 44 & 45 & PED 3L.

Photo 11: Left side view of sections 44 & 45 & PED 3L.

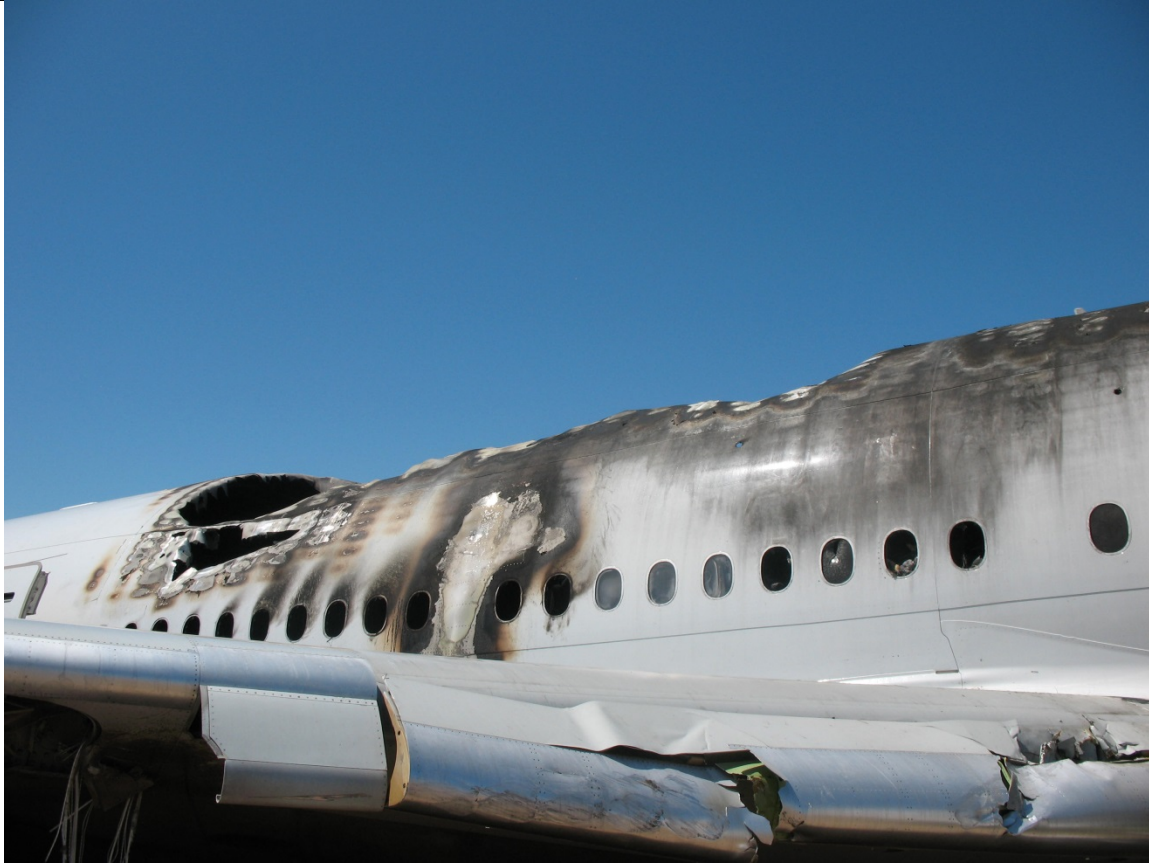
Description: Left side view of sections 44 & 45.
--

Photo 12: Left side view of sections 44 & 45.

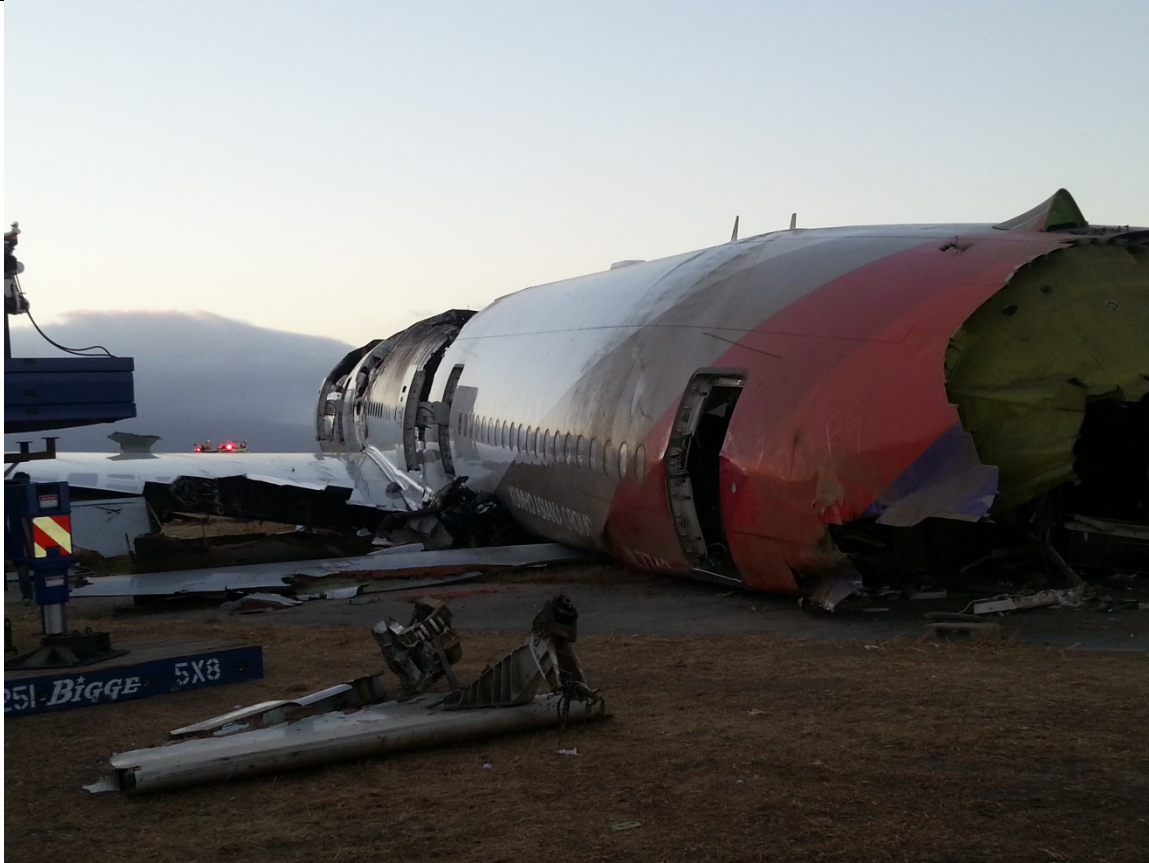
Description: Left side view of sections 46 & 47.
--

Photo 13: Left side view of sections 46 & 47.

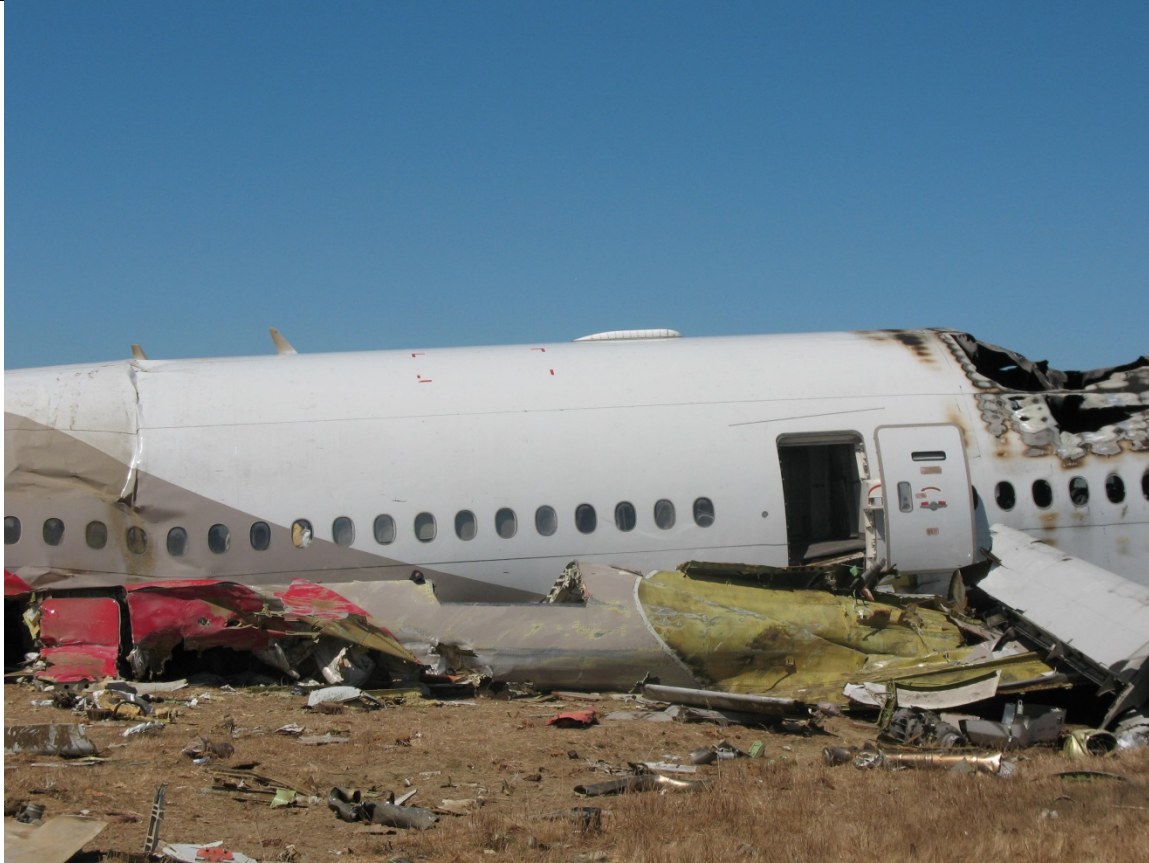
Description: Left side view of section 46 & PED 3R.

Photo 14: Left side view of section 46 & PED 3R.

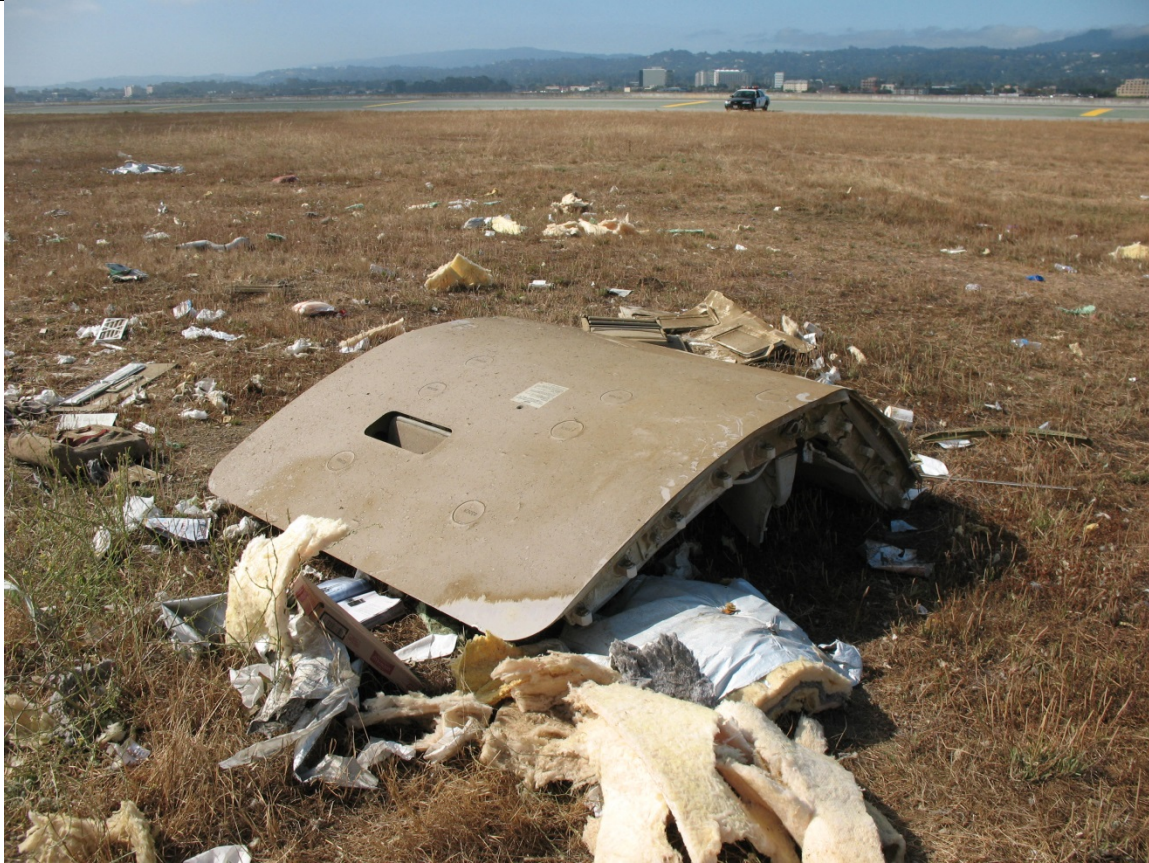
Accident #: DCA13MA120	HL7742
Description: Detached small aft cargo door (SACD).

Photo 15: Detached small aft cargo door (SACD).

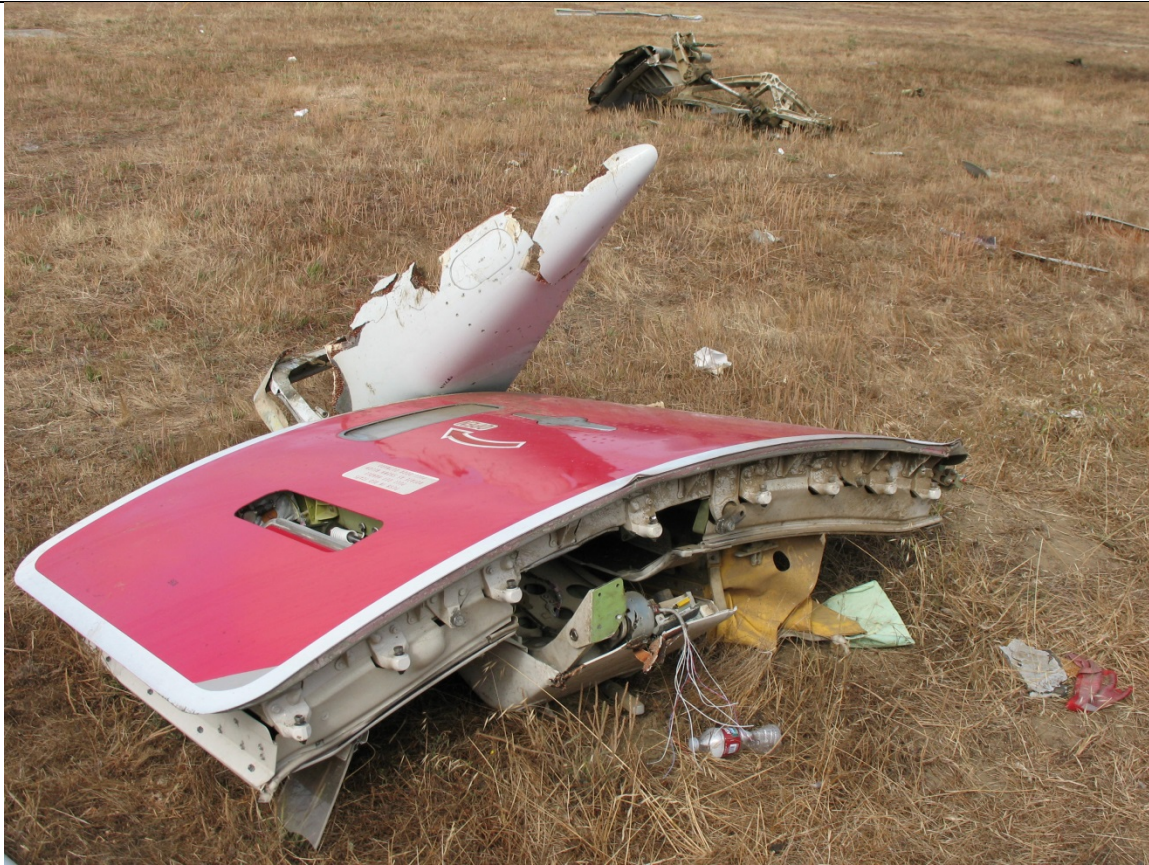
Description: Detached PED 4L.

Photo 16: Detached PED 4L.

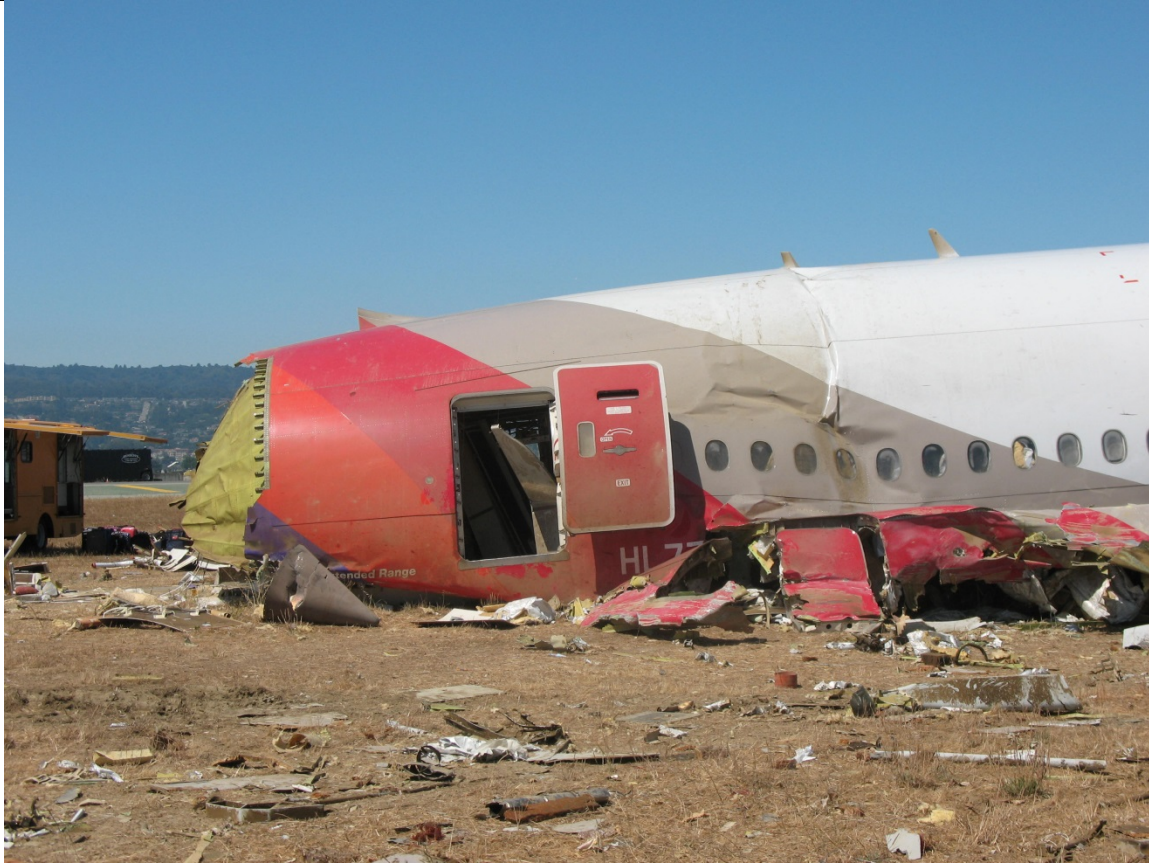
Description: Right side view of section 47. PED 4R and the bulk cargo door.

Photo 17: Right side view of section 47. PED 4R and the bulk cargo door.

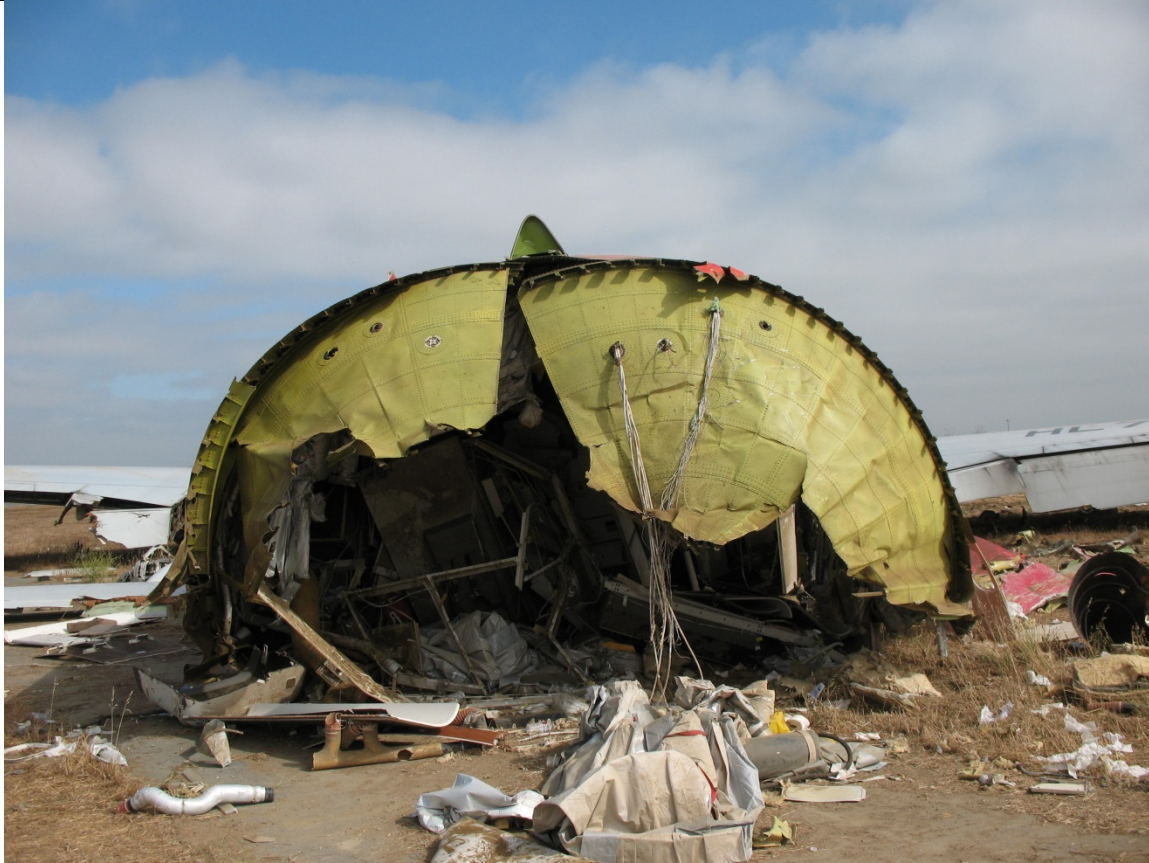
Description: Section 48 aft pressure bulkhead (APB).
--

Photo 18: Section 48 aft pressure bulkhead (APB).

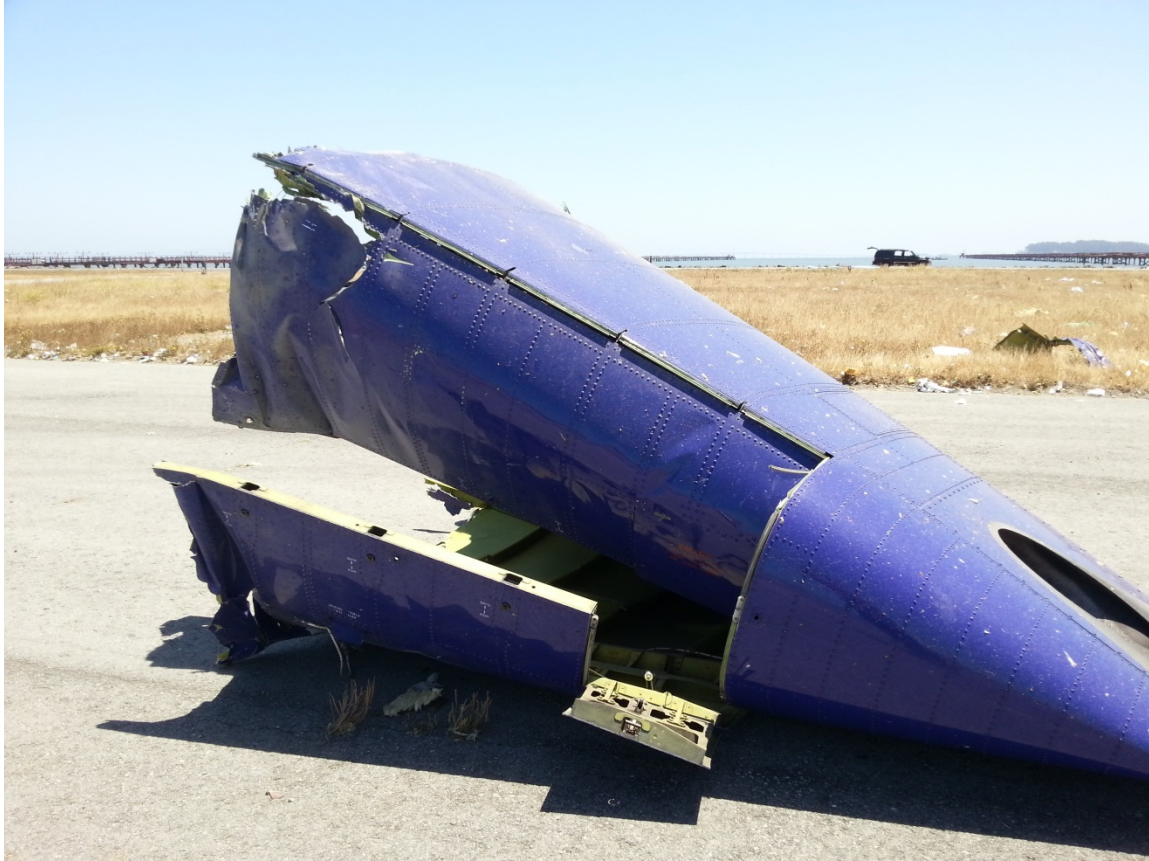
Description: Section 48 auxiliary power unit (APU) compartment.

Photo 19: Section 48 auxiliary power unit (APU) compartment.

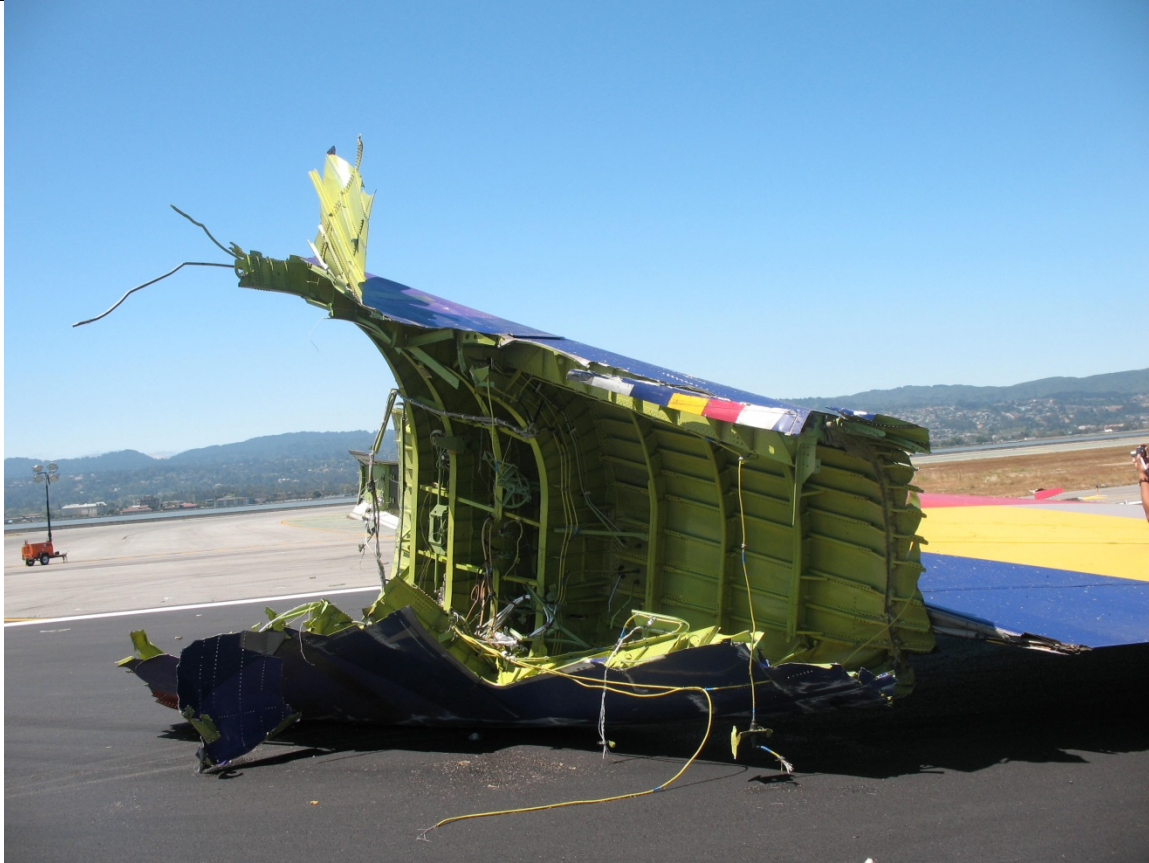
Description: Upper crown section of section 48 below the vertical stabilizer.

Photo 20: Upper crown section of section 48 below the vertical stabilizer.

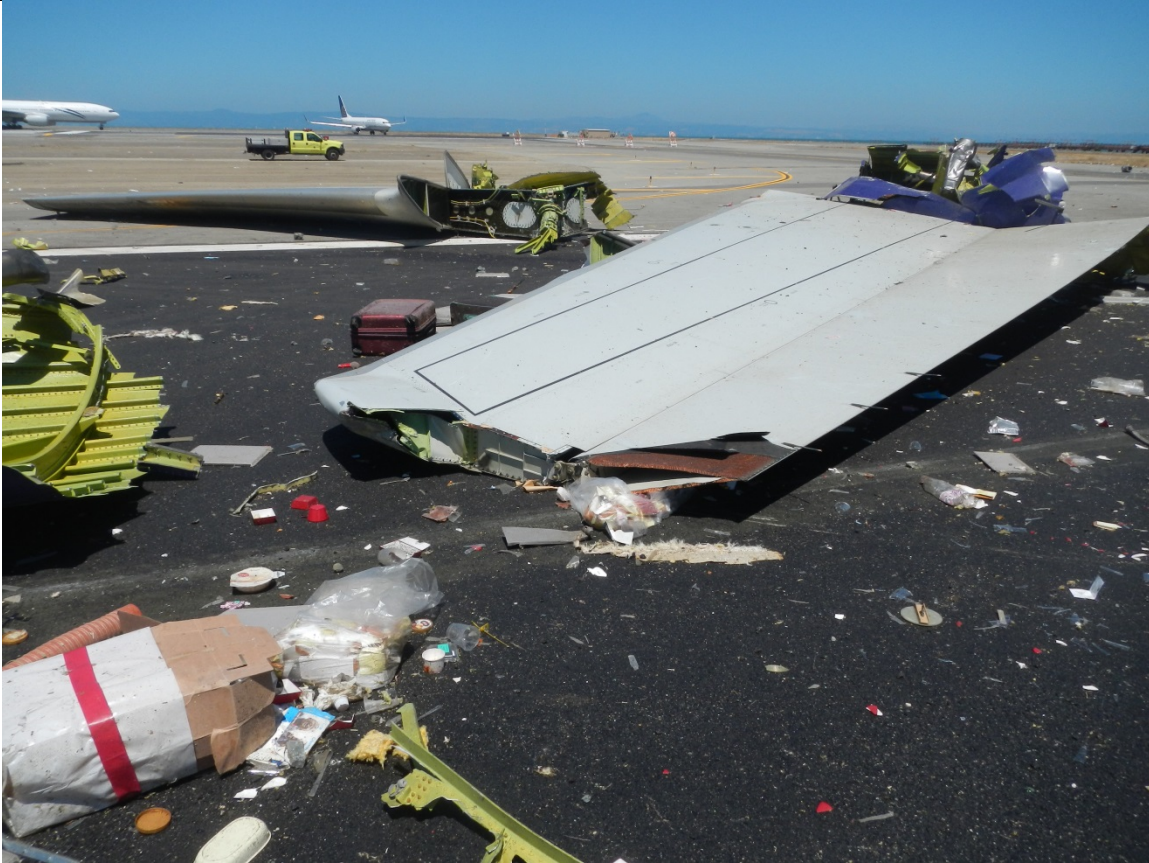
Description: Left hand horizontal stabilizer and elevator.

Photo 21: Left hand horizontal stabilizer and elevator.

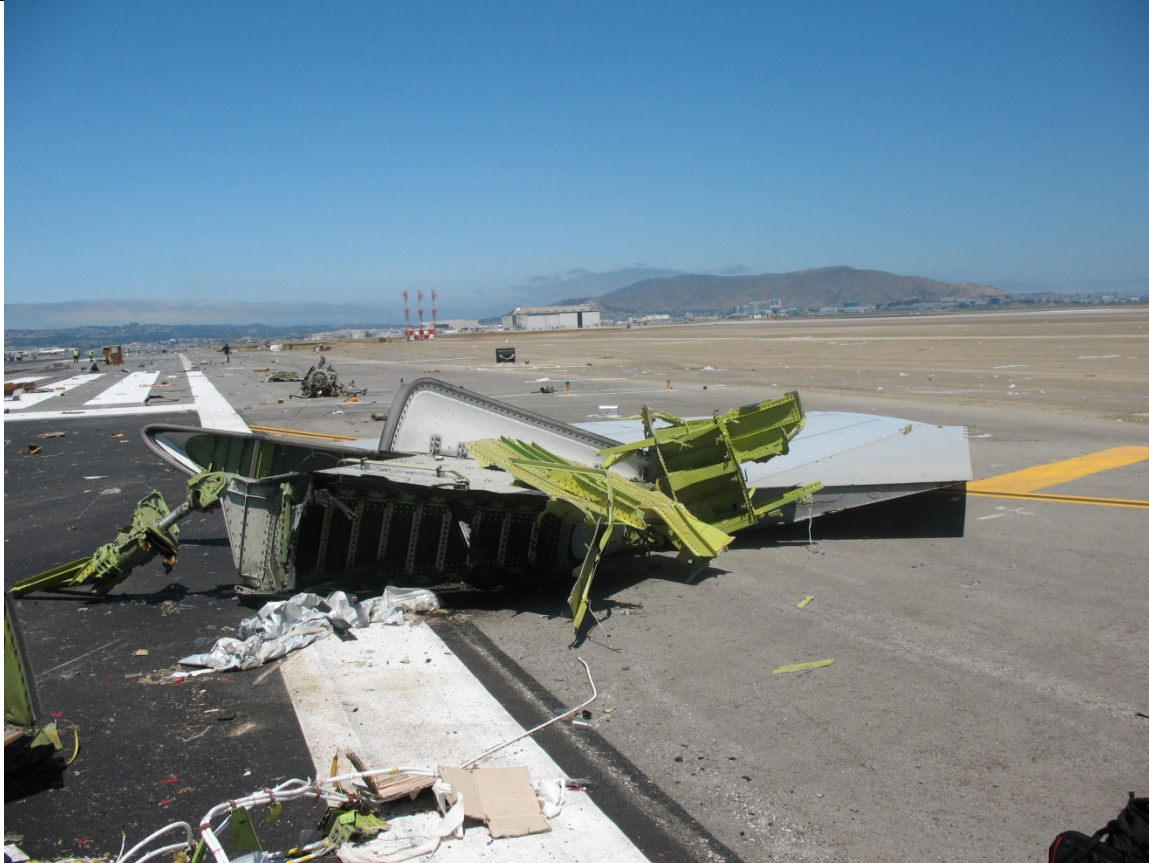
Description: Right hand side horizontal stabilizer and jackscrew.

Photo 22: Right hand side horizontal stabilizer and jackscrew.
